" बागडीगी कोलियरी में हुयी दुर्घटना की जांच रिपोर्ट । "

बागडिगी कोलियरी में हुयी दुर्घटना की जाँच रिपोर्ट

S.O. 118(E).— In pursuance of section 27 of the Mines Act, 1952 (35 of 1952), the Central Government hereby publishes, as Annexure to this notification, the following report submitted to it under sub-section (4) of section 24 of the said Act by the Court of Inquiry appointed to hold an inquiry into the causes and circumstances attending the accidents which occurred on the 2nd February, 2001 in the Bagdighi Colliery of M/s Bharat Coking Coal Limited in District Dhanbad, State of Jharkhand :-

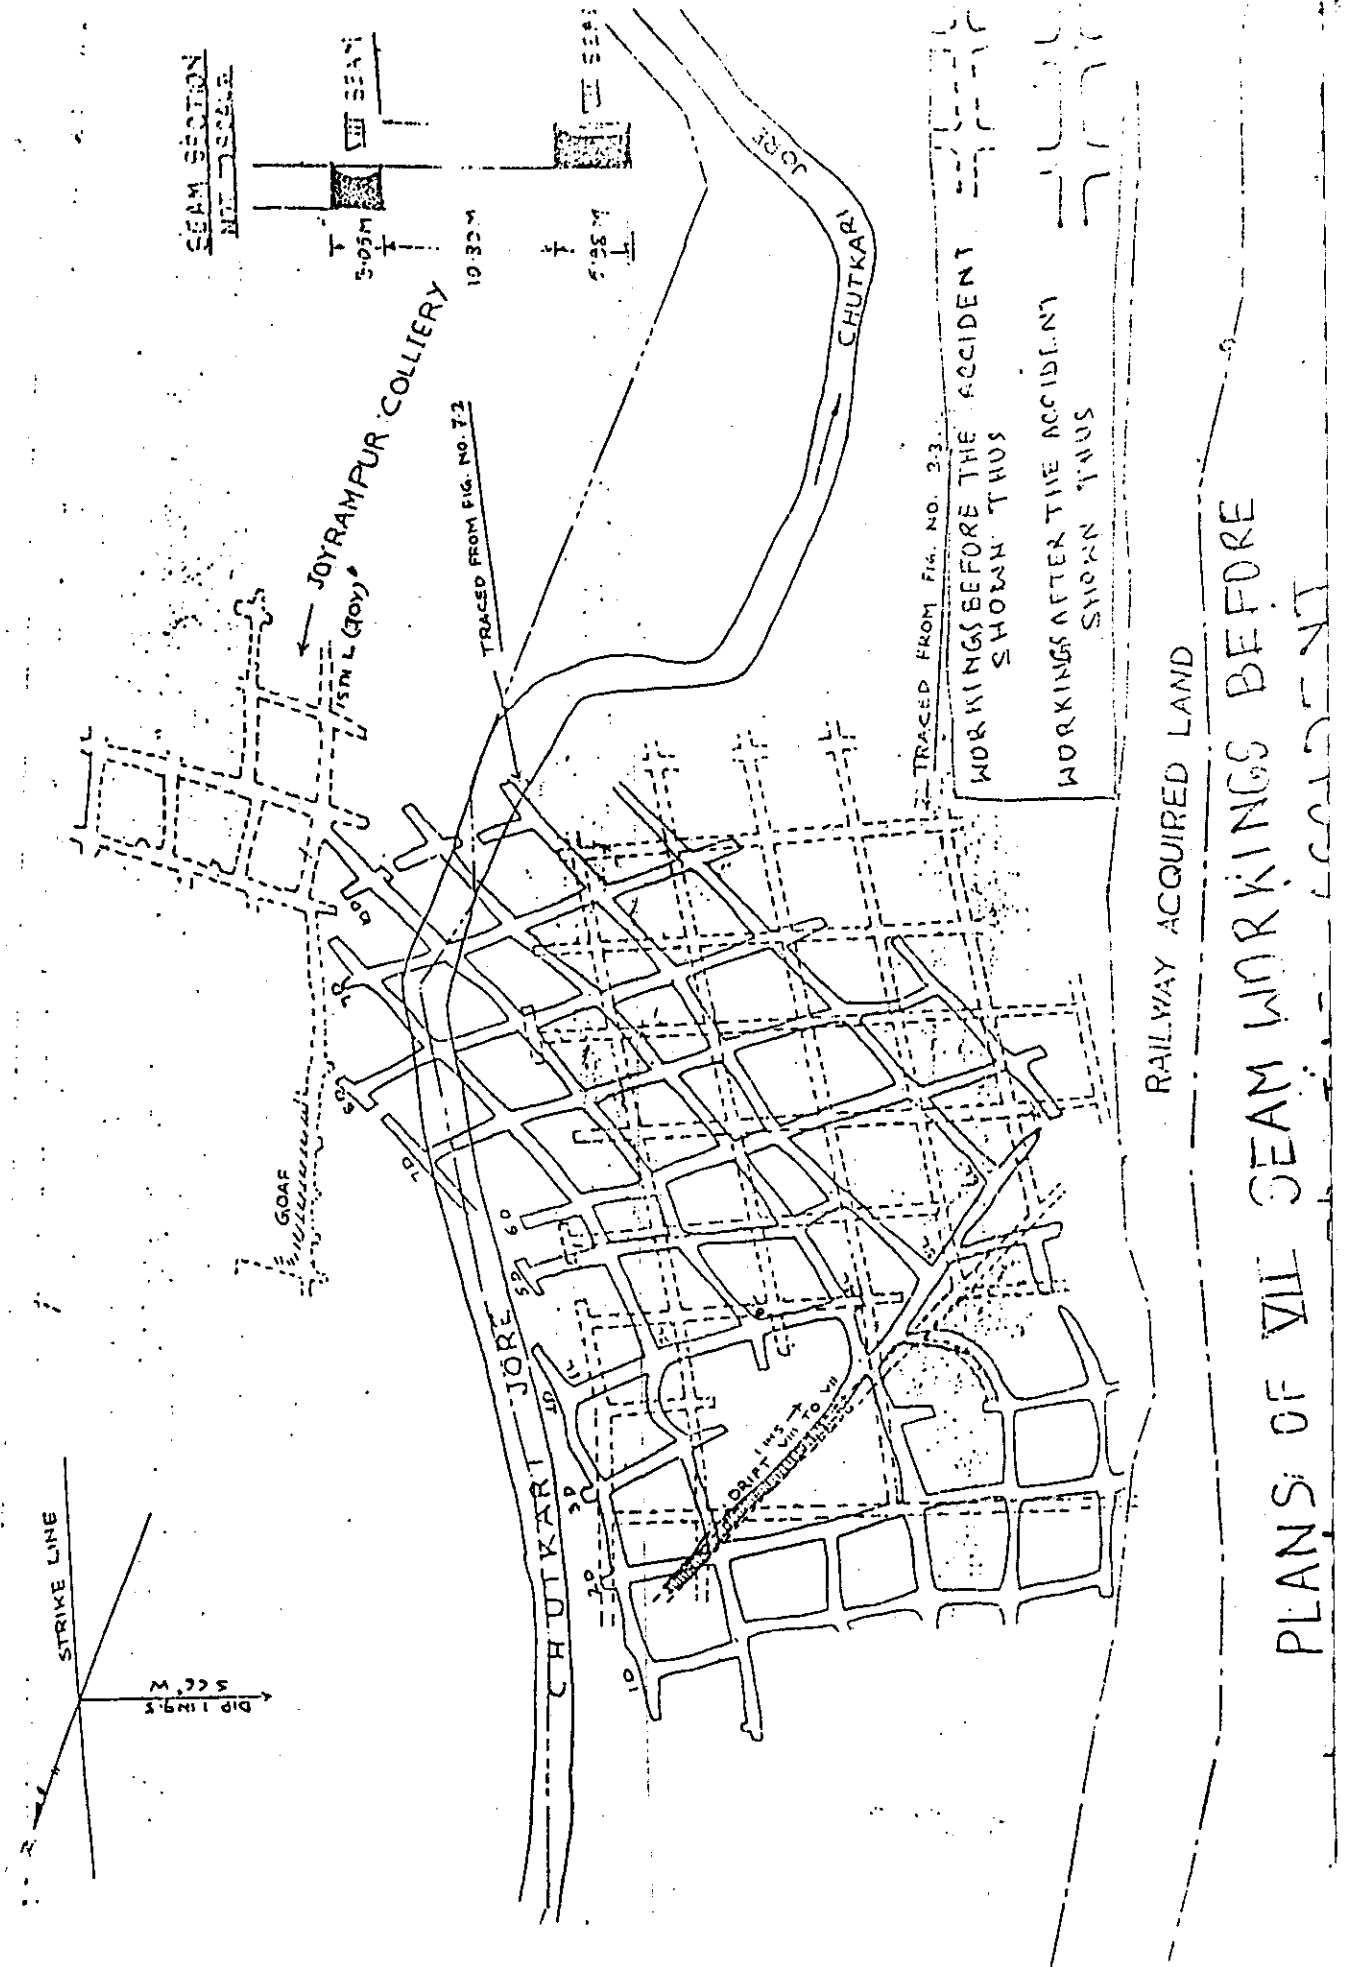
STAKE LINE 2ND AUG. 55

On studying the working plan, admittedly prepared by the surveyors, Sri R.N. Kundu and Sri R.C. Das, there appear glaring defects and infirmities. To mention a few, working plans do not indicate any spot levels at all. The sizes of the pillars in the galleries of 4th and 5th levels are also not truthfully depicted. The above defects are not only glaring, but also conspicuous and should have been observed even by a cursory glance at the working plans. It is intriguing as to how these defects had escaped the notice and attention of not only the surveyors themselves, but also the manager and the agent of the colliery, as well as the team of officials, who claim to have conducted check survey of the colliery.

Therefore, the above named three surveyors cannot escape the primary responsibility for having grossly failed to perform their duties and for their misconduct in having violated the statutory provisions of law, relating to preparation and maintenance of plans and sections. These surveyors have apparently violated the provisions of Regulations 49, 58(3) and 64(4) of the Coal Mines Regulations, 1957. These surveyors have also violated the circular issued by DGMS by failing to prepare and maintain proper water danger plan knowing fully well that there was constant danger of inundation from water-logged body of Jayrampur colliery which even according to original projection plan was at a distance of hardly 78m. i.e. much below the statutory caution-line of 120m.
